RIVERBANK ASSESSMENT

Wild & Scenic River Segment West Branch & Farmington Rivers

MMI #2056-04-1

September 2005

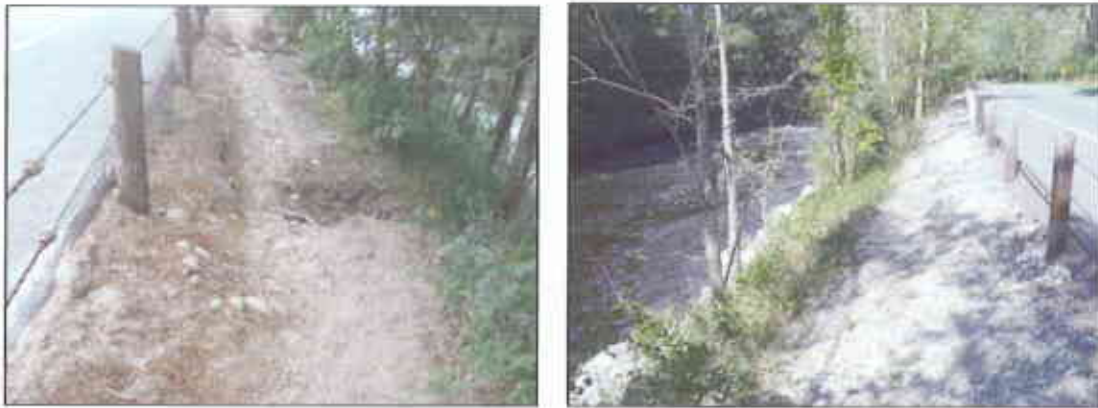
Portions of Route 181, East River Road, and Route 20 suffer from gully erosion. The most severe gully erosion was documented across from the drive-in theatre and Riverside Cemetery, both located along Route 181. The photos below illustrate examples of erosion caused by sheet flow runoff from nearby roadways.

Gullies resulting from sheet flow runoff along nearby roads.

In order to reduce bank erosion and prevent gully formation and/or road undermining, installation of a conventional curb and catch basin system is recommended along areas such as those presented above. Due to the steep banks along portions of this river, a conventional catch basin system would need to be modified. An illustration of potential modifications to catch basins and culverts is presented on Figure 6A. Such modifications may include installation of deeper catch basins, relocation of existing culverts and catch basin outfalls to the toe of riverbank and construction of stone scour dissipaters at outfalls. Figure 6B is a typical detail for a low impact gully repair, using a buried perforated pipe for drainage.

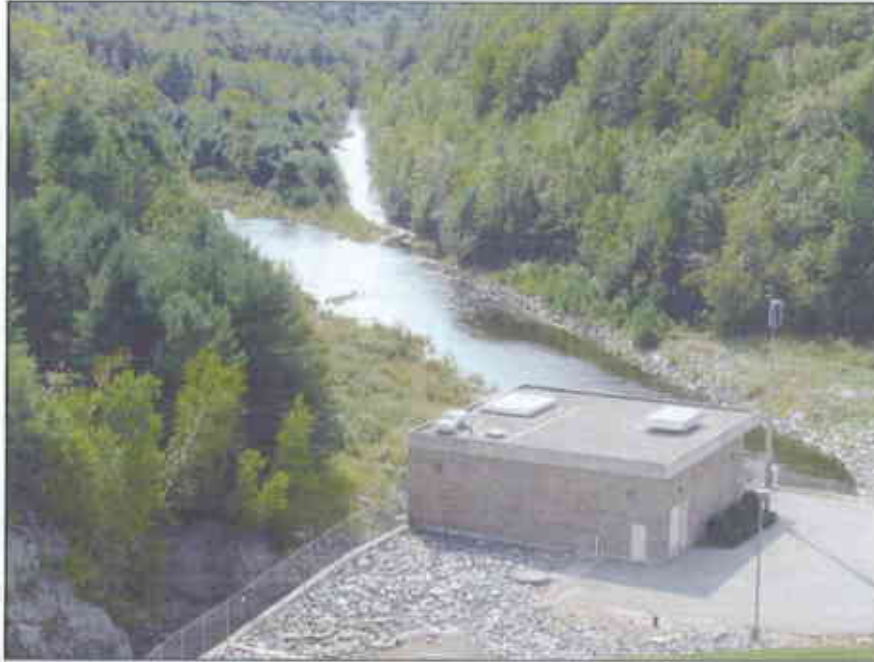
Segment 1A Hogback Dam tailrace with bifurcated channel

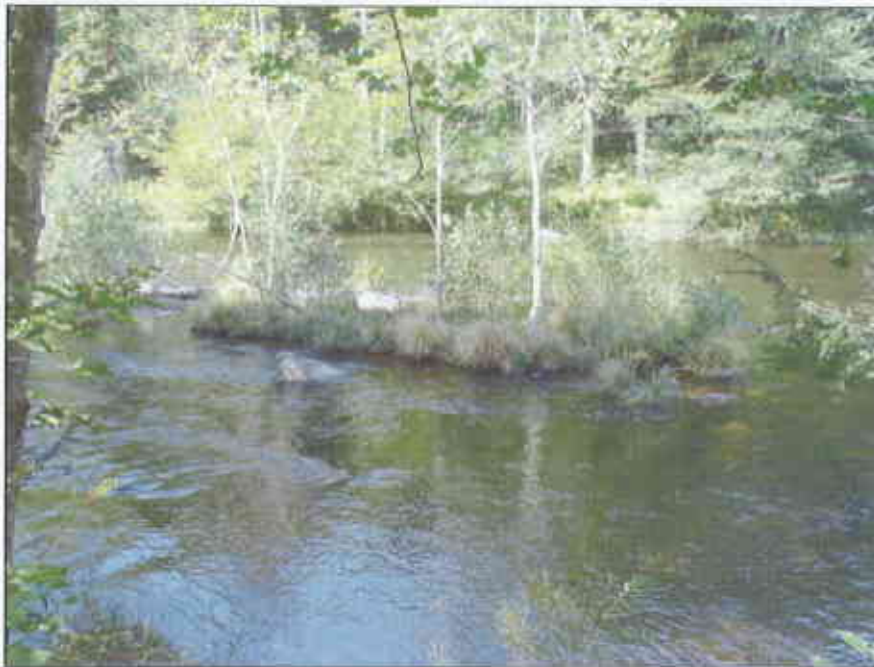
Segment 1A Well Vegetated Island observed within the West Branch

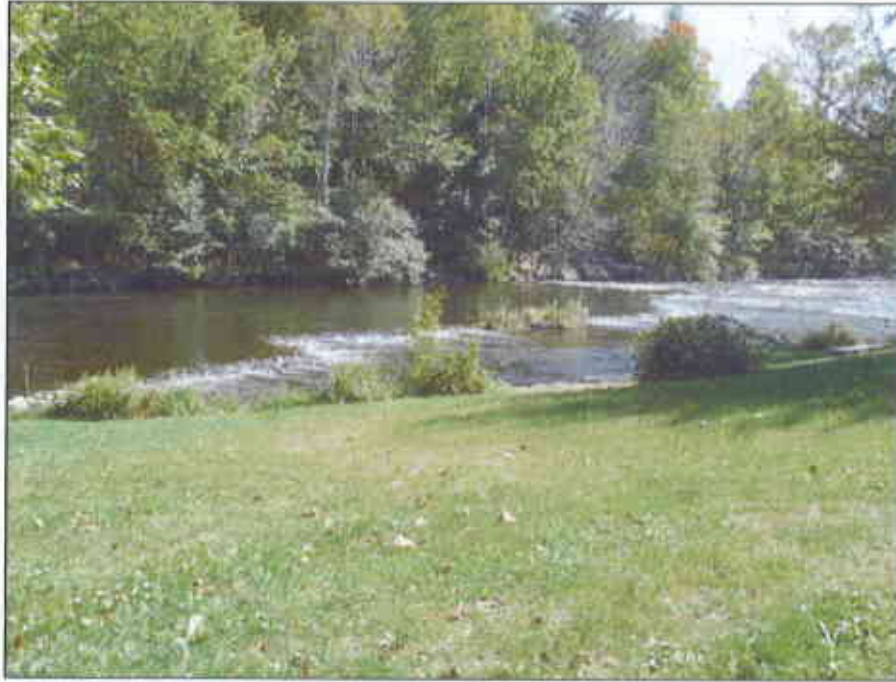
Stable banks along Segment 1B the right (west) bank of the West Branch, however artificial stone weir has been constructed and natural riparian vegetation has been removed.

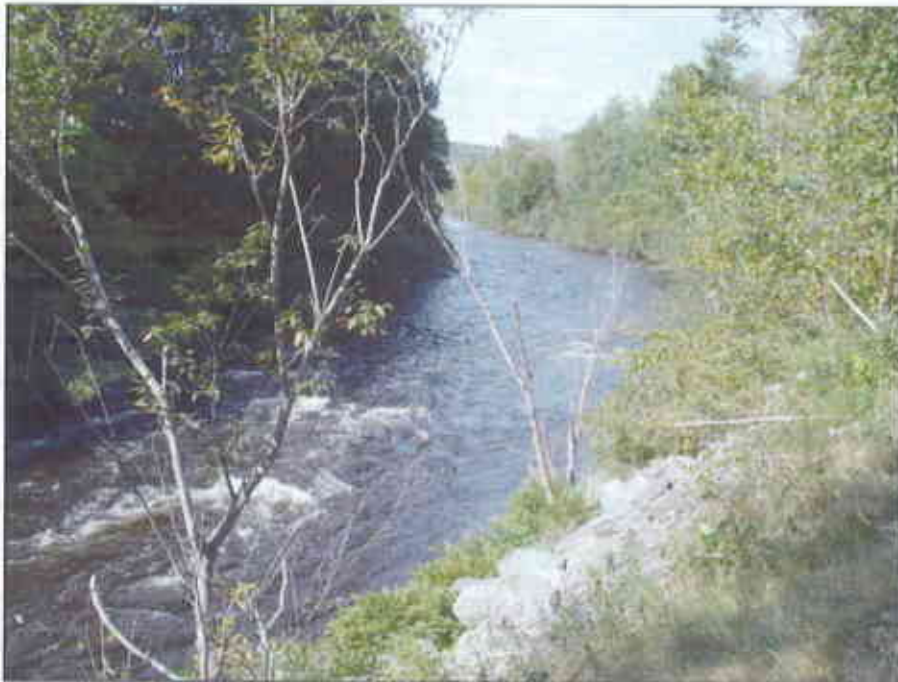
Vegetation and riprap armament located within Segment 1A along the left (east) bank of the Upper West Branch

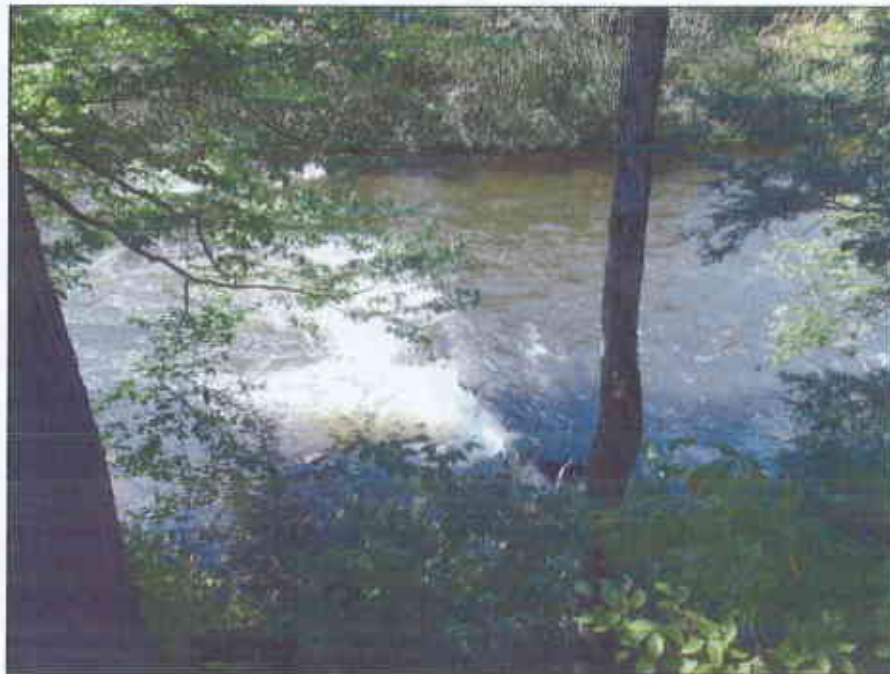
Riffles caused by downed log located in Segment 1B

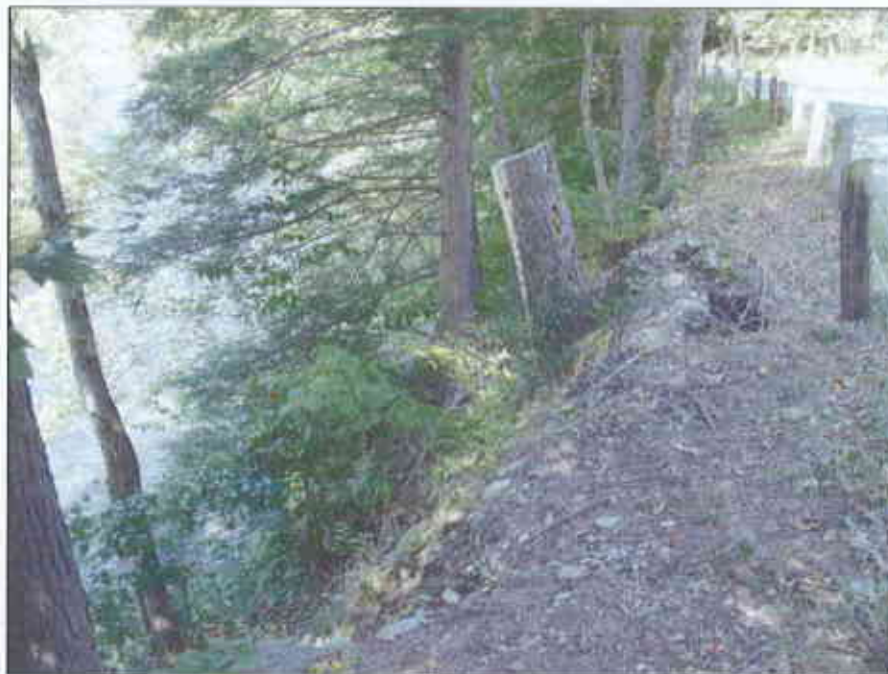
Bank Instability located within Segment 1B on left (east) bank of the West branch

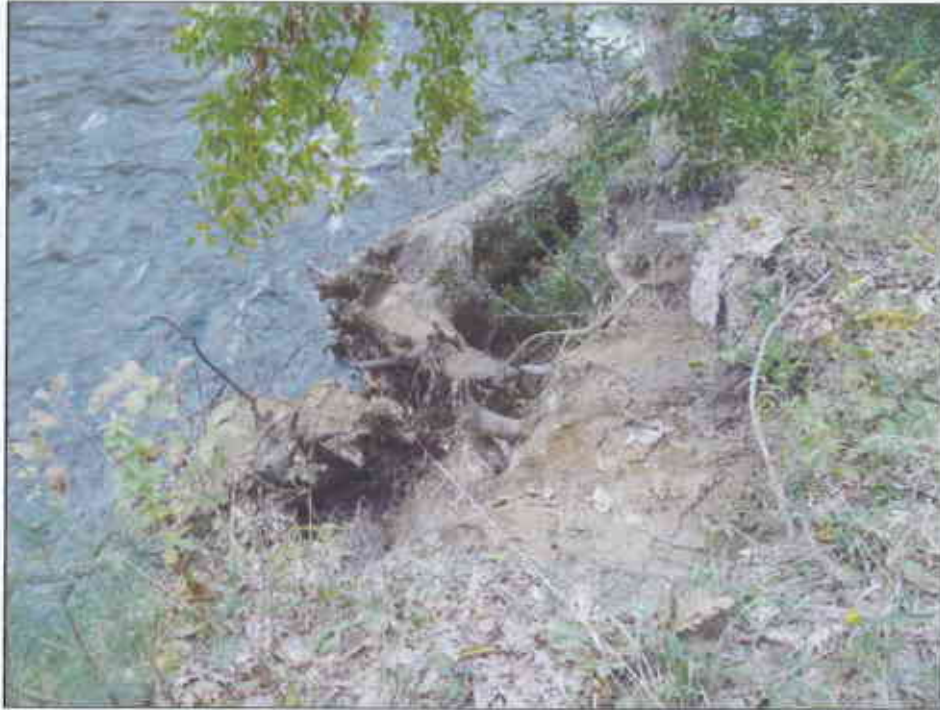
Bank Instability observed along the right (west) bank of the Farmington River

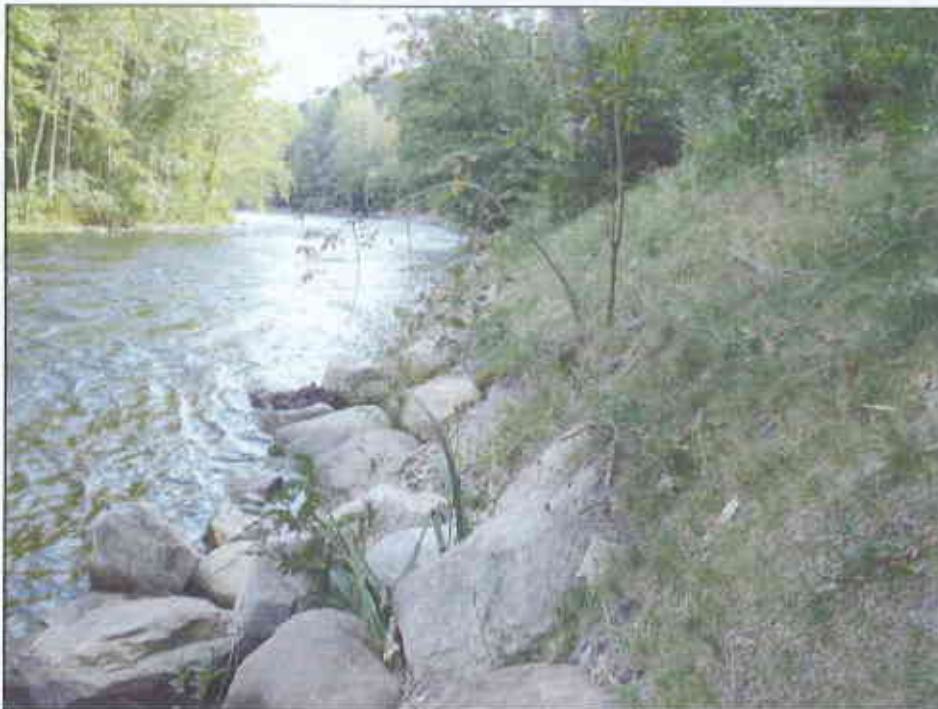
Bank stabilization project located within Segment 1B illustrating rock armament at rivers edge with well vegetated, stable banks.

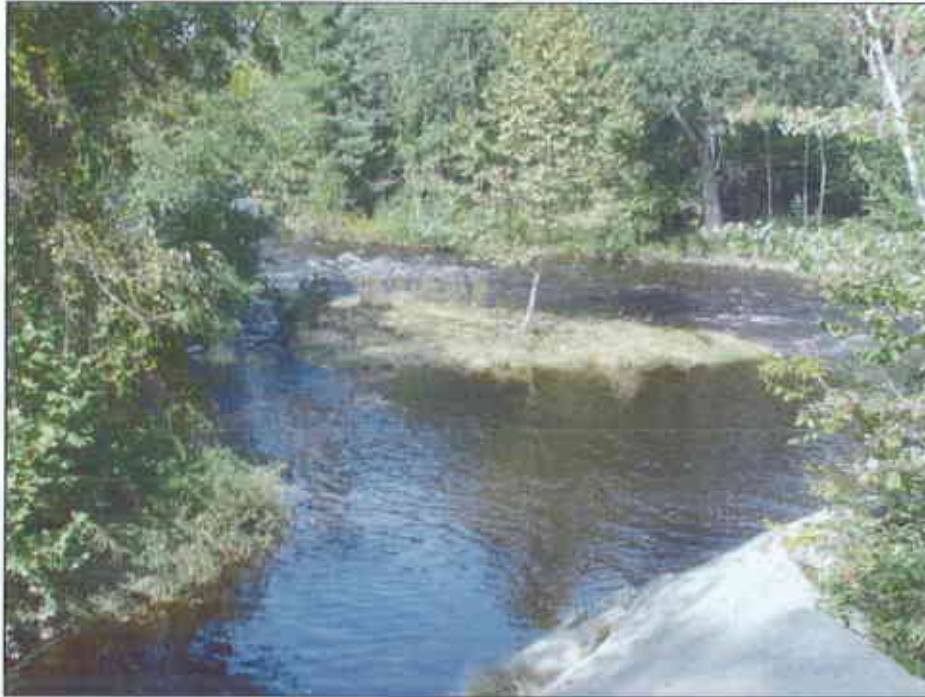
Well vegetated and stable river banks and island located at the confluence of the Still River and the West Branch at Segment 1B/2.

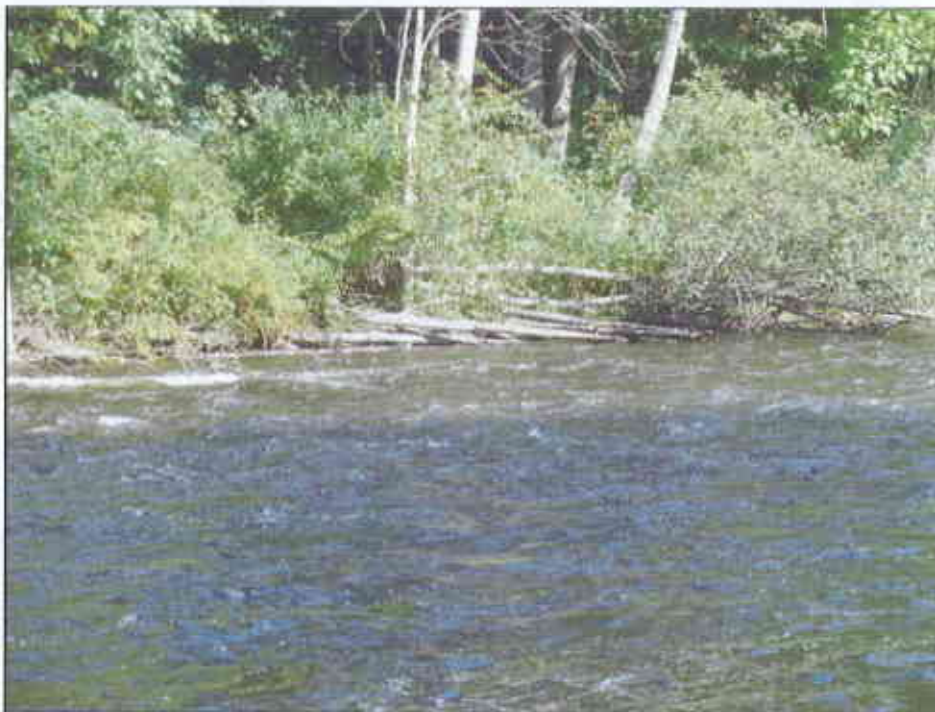
Fallen trees with dense shrub zone located along the left (east) bank of the West Branch

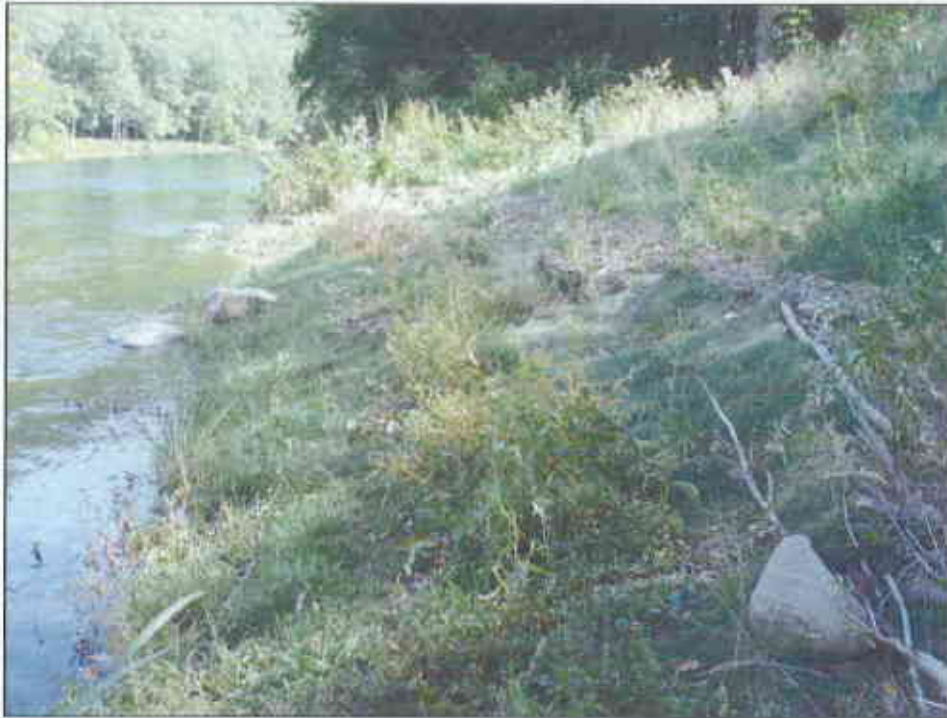
River banks well vegetated and stable at the Tennessee gas pipeline crossing

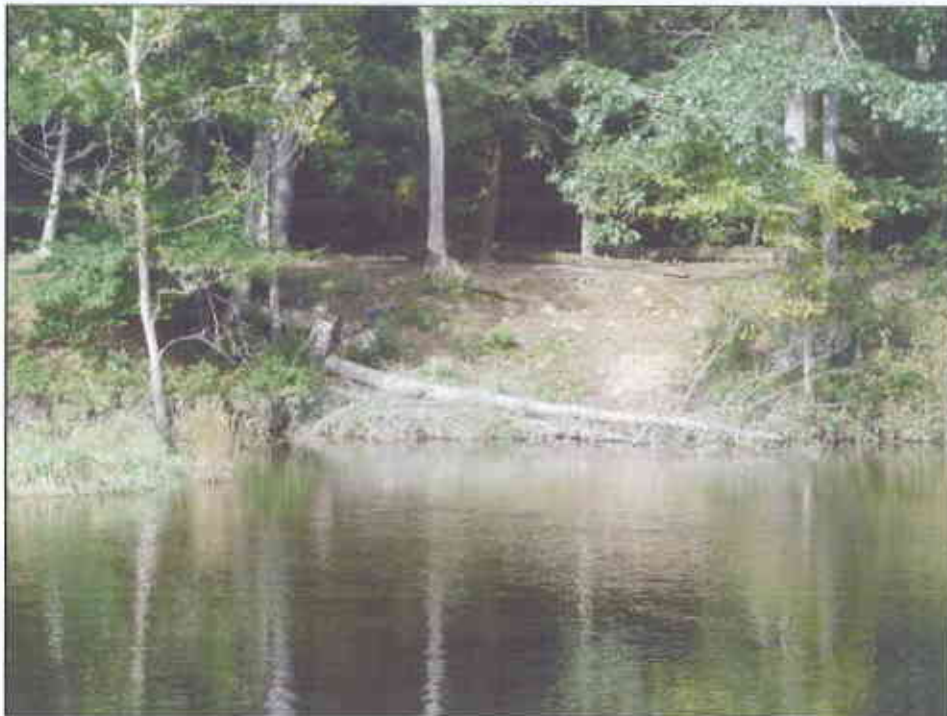
Minor bank erosion located along the left (east) bank within CTDEP State Park.

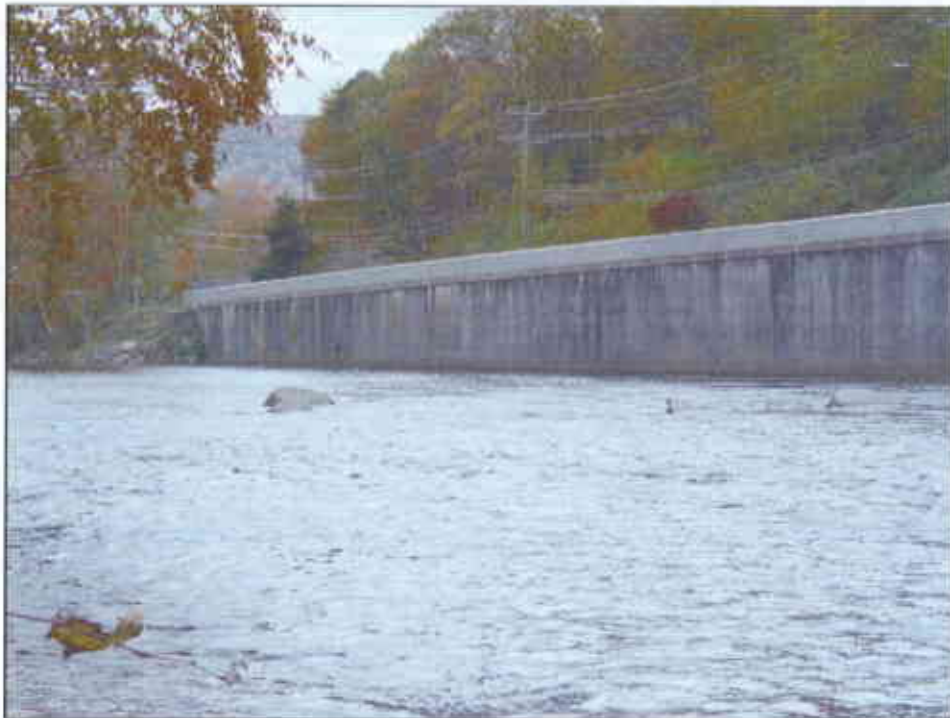
Route 44 retaining wall located along the right (west) bank of West Branch

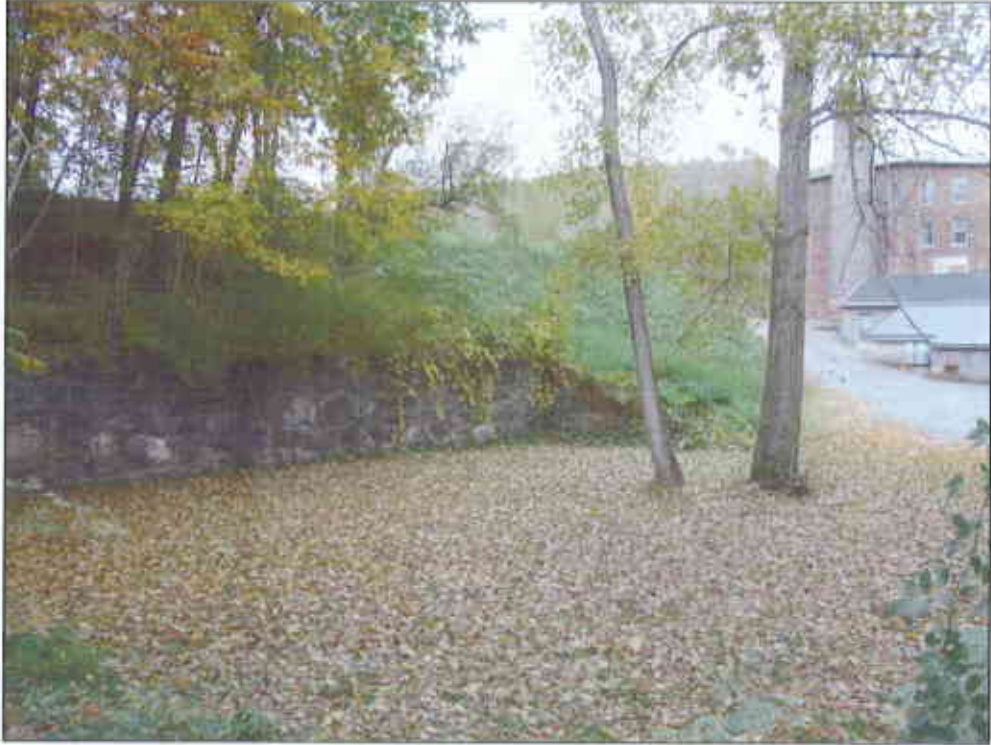
**Old Greenville Dam located along the left (east) bank of the
West Branch in Segment 3**

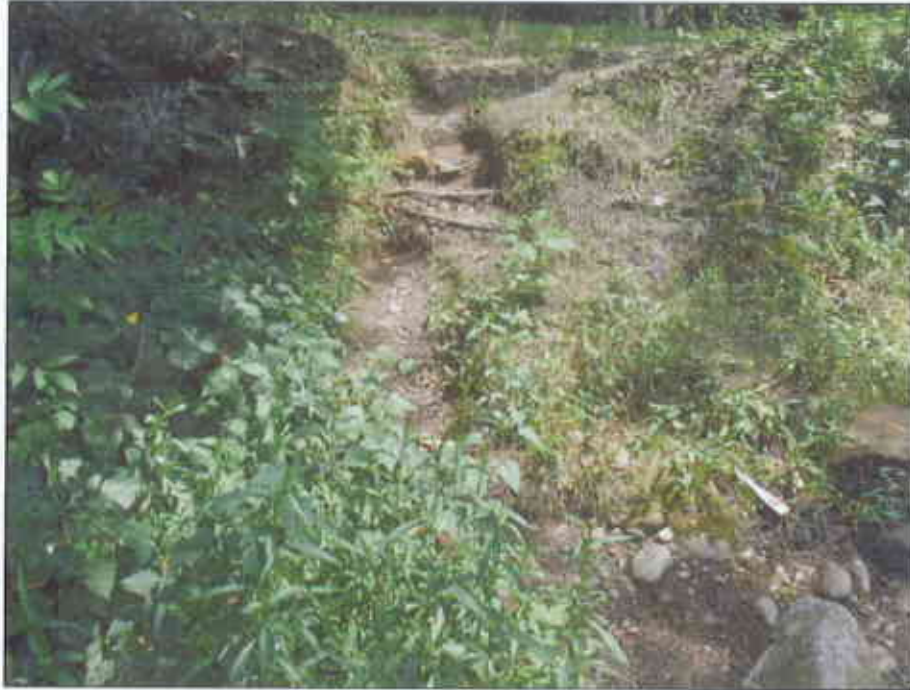
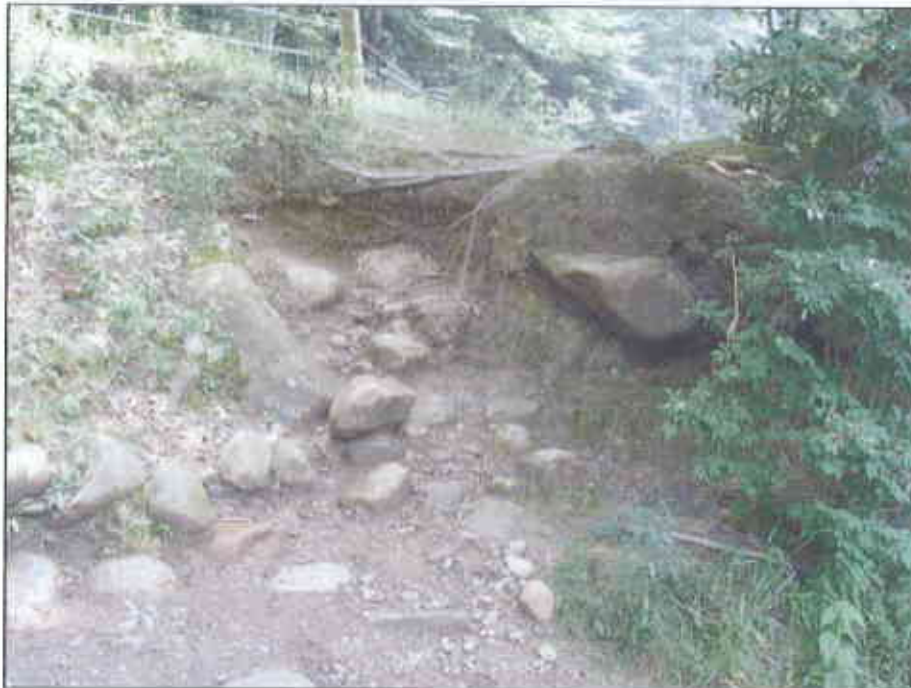
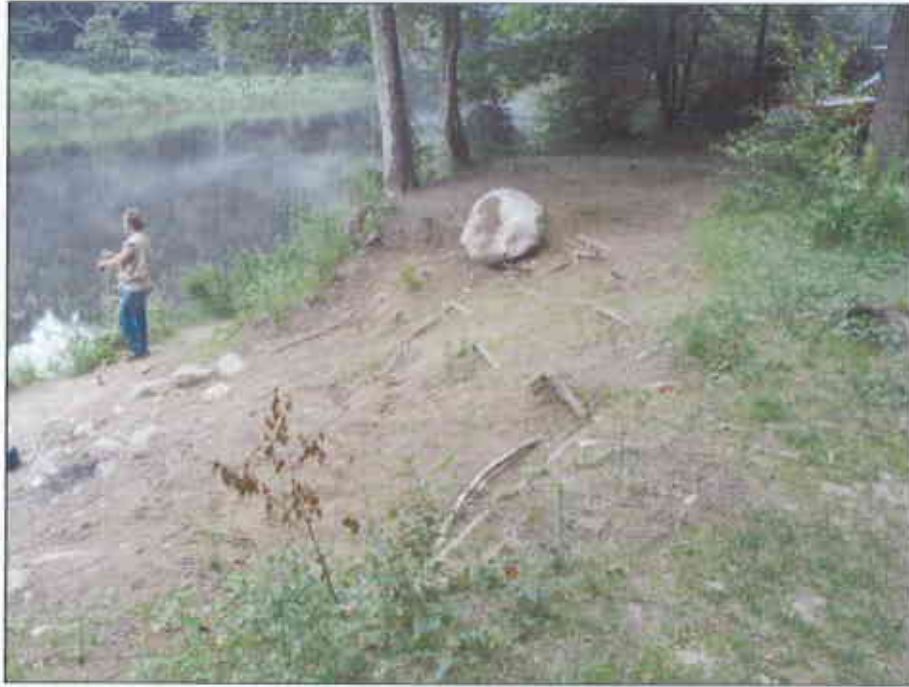
Access Point S21

MMI observed that only a few access trails require immediate attention due to excessive erosion. These sites include S21, S38, and S56. A photo log of these sites is appended. The erosion at these sites is attributed to high foot traffic. These areas have been trampled and striped of their vegetation, which has led to bank erosion. Luckily, roots from surrounding trees have temporarily prevented further erosion from occurring at several locations. Even though tree roots help to stabilize the exposed banks, these access locations should be remediated.

Remediation suggestions include the use of natural stone stairways, log revetments, biodegradable erosion control blankets, and hydromulch. The photos presented below illustrate a log revetment and natural stone stairway system that were constructed along the river's banks several years ago.

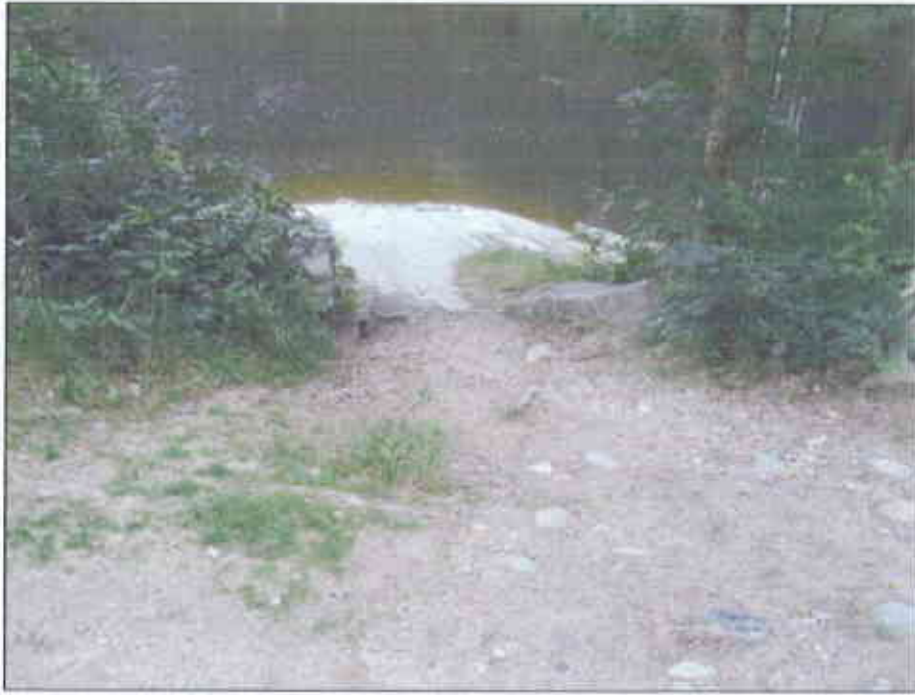
Access Point S76

Access point S76 is located along the right bank of the river and can be accessed via River Road. This access point is relatively steep, with exposed soil on the upper portion of the trail and bedrock on the lower portion. Construction of a stone or log stairway is recommended at the upper portion to stabilize the riverbank and provide safer access.

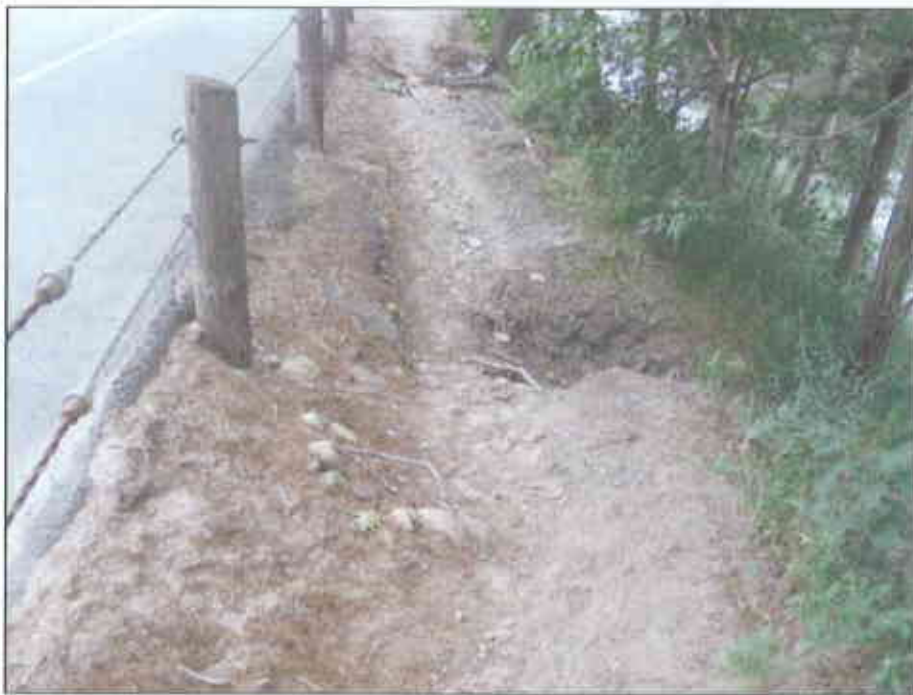
Route 181 East Shoulder with Gully Erosion

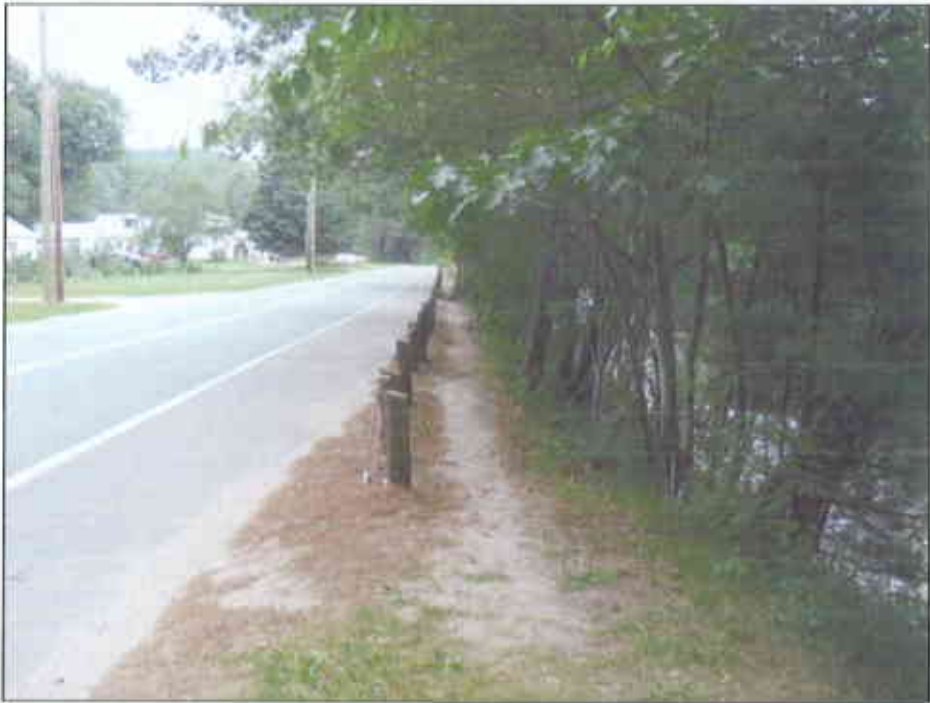
Route 181 East Shoulder with Gully Erosion
