RIVERBANK ASSESSMENT

Wild & Scenic River Segment West Branch & Farmington Rivers

MMI #2056-04-1

September 2005

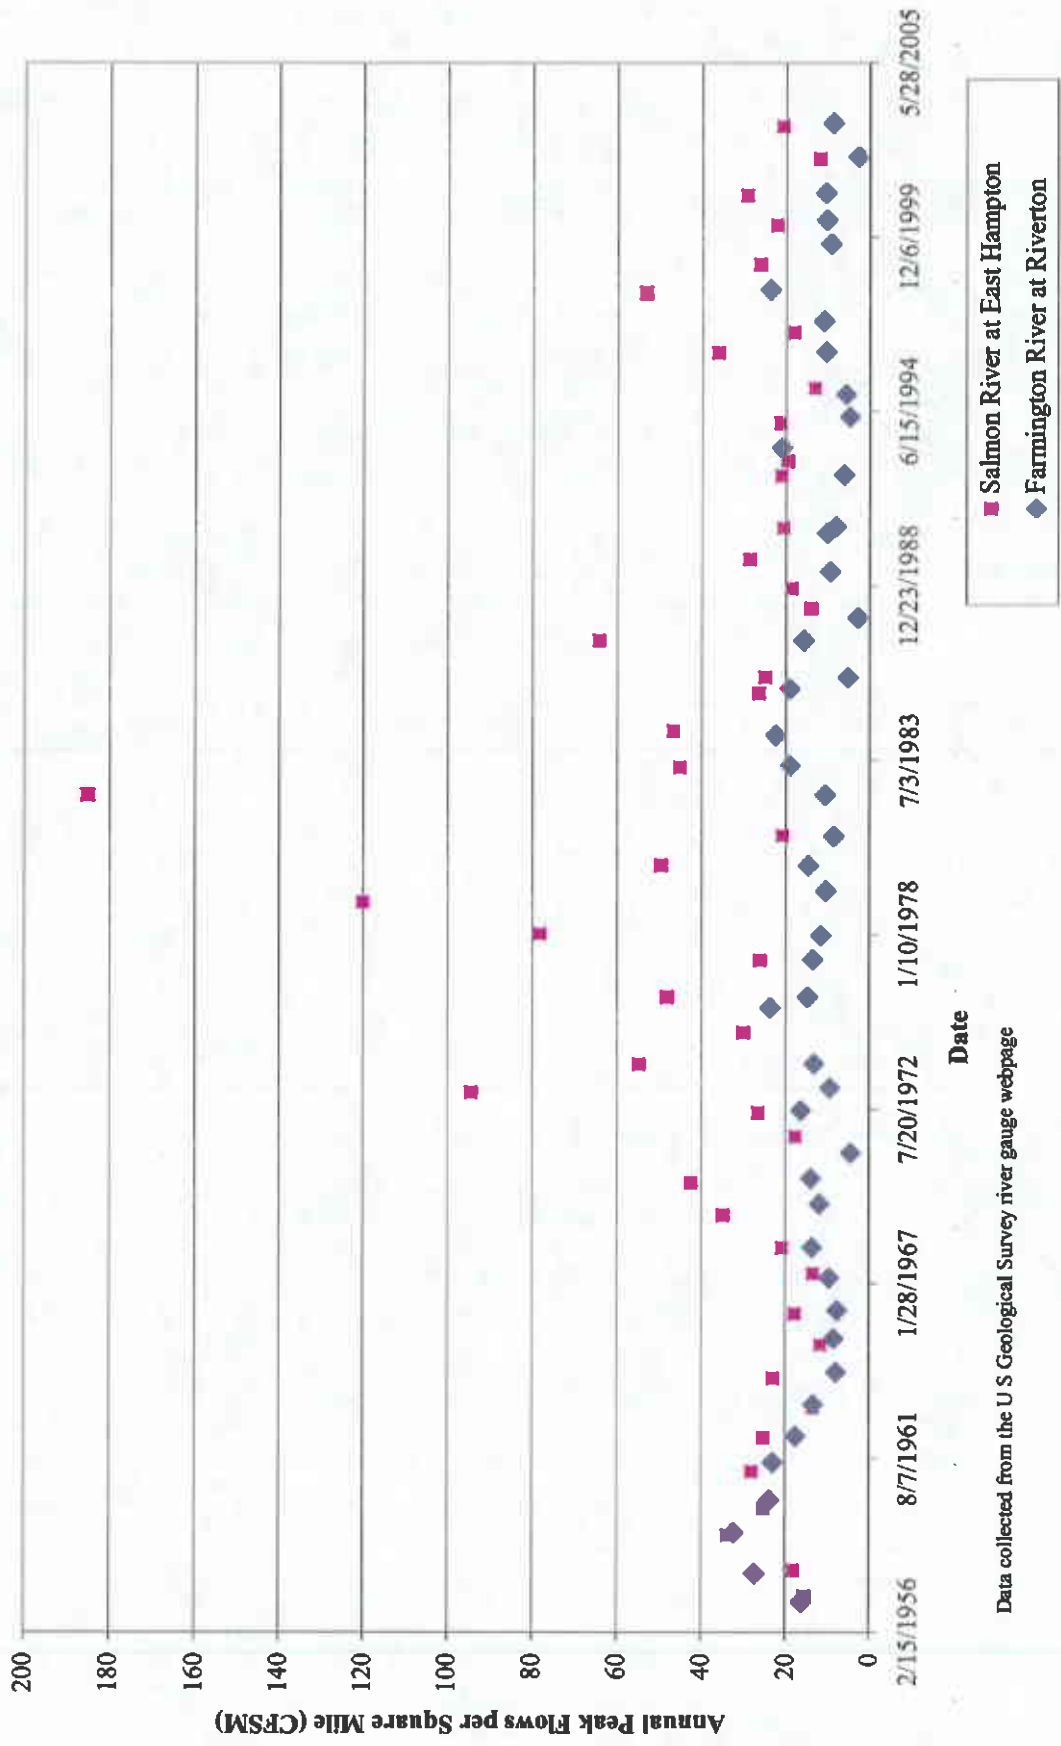
Figure 3
Comparison of Peak Flows per Square Mile for
Salmon River at East Hampton vs Farmington River at Riverton from 1957 - 2003

exceeded 20 cubic feet per second per square mile (cfsm) only four times from 1970 to 2003, while the Salmon River exceeded 20 cfsm on 27 occasions. This can be seen graphically in Figure 3.

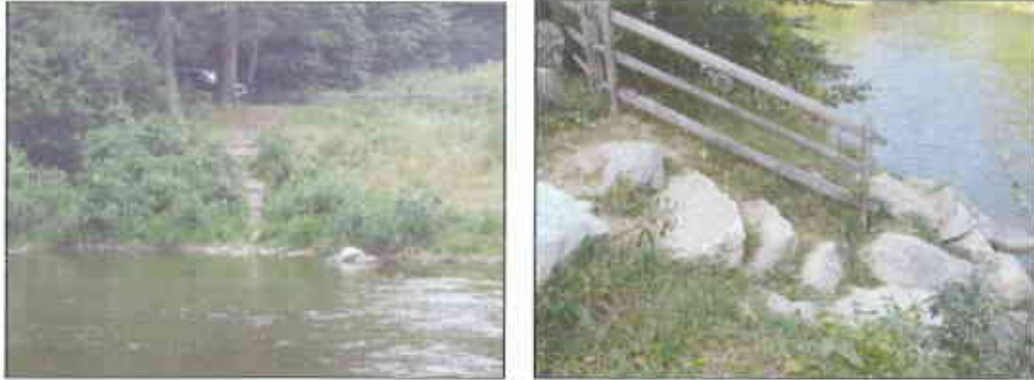
MMI observed that only a few access trails require immediate attention due to excessive erosion. These sites include S21, S38, and S56. A photo log of these sites is appended. The erosion at these sites is attributed to high foot traffic. These areas have been trampled and striped of their vegetation, which has led to bank erosion. Luckily, roots from surrounding trees have temporarily prevented further erosion from occurring at several locations. Even though tree roots help to stabilize the exposed banks, these access locations should be remediated.

Log Revetments and Natural Stone Stairways constructed along the river.

Remediation suggestions include the use of natural stone stairways, log revetments, biodegradable erosion control blankets, and hydromulch. The photos presented below illustrate a log revetment and natural stone stairway system that were constructed along the river's banks several years ago.

These measures provide bank stabilization, ease of access (i.e. safety), are aesthetically attractive, and are an inexpensive solution for remediating access trail erosion along the watercourse.

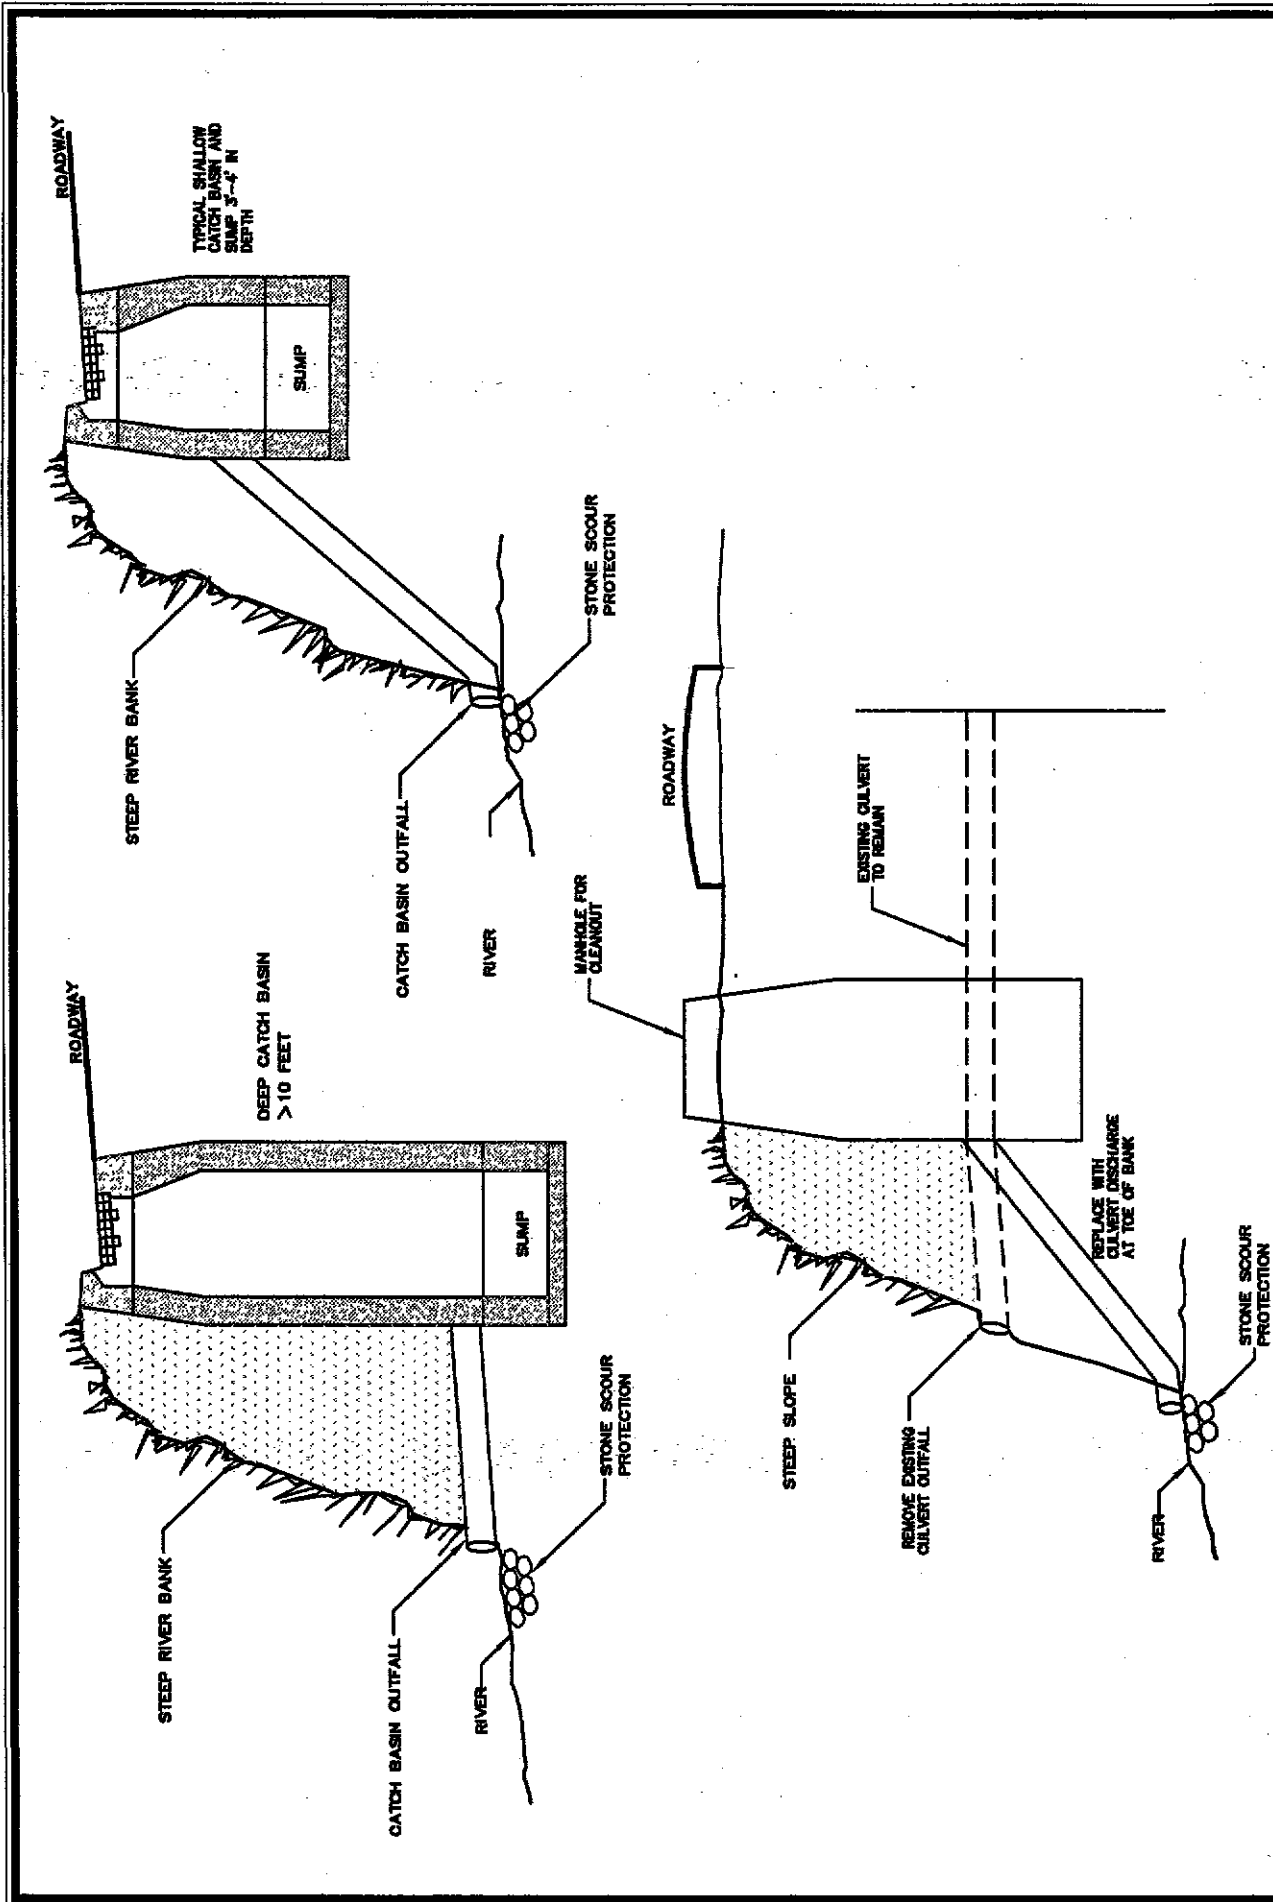
SHEET: _____
FIGURE 6A

Gullies resulting from sheet flow runoff along nearby roads.

In order to reduce bank erosion and prevent gully formation and/or road undermining, installation of a conventional curb and catch basin system is recommended along areas such as those presented above. Due to the steep banks along portions of this river, a conventional catch basin system would need to be modified. An illustration of potential modifications to catch basins and culverts is presented on Figure 6A. Such modifications may include installation of deeper catch basins, relocation of existing culverts and catch basin outfalls to the toe of riverbank and construction of stone scour dissipaters at outfalls. Figure 6B is a typical detail for a low impact gully repair, using a buried perforated pipe for drainage.

RIVERBANK GULLEY REPAIR DETAIL
