**UPPER FARMINGTON RIVER
 MANAGEMENT PLAN
 FIGURE 15
 LOCAL BASIN
 PERCENT IMPERVIOUS**

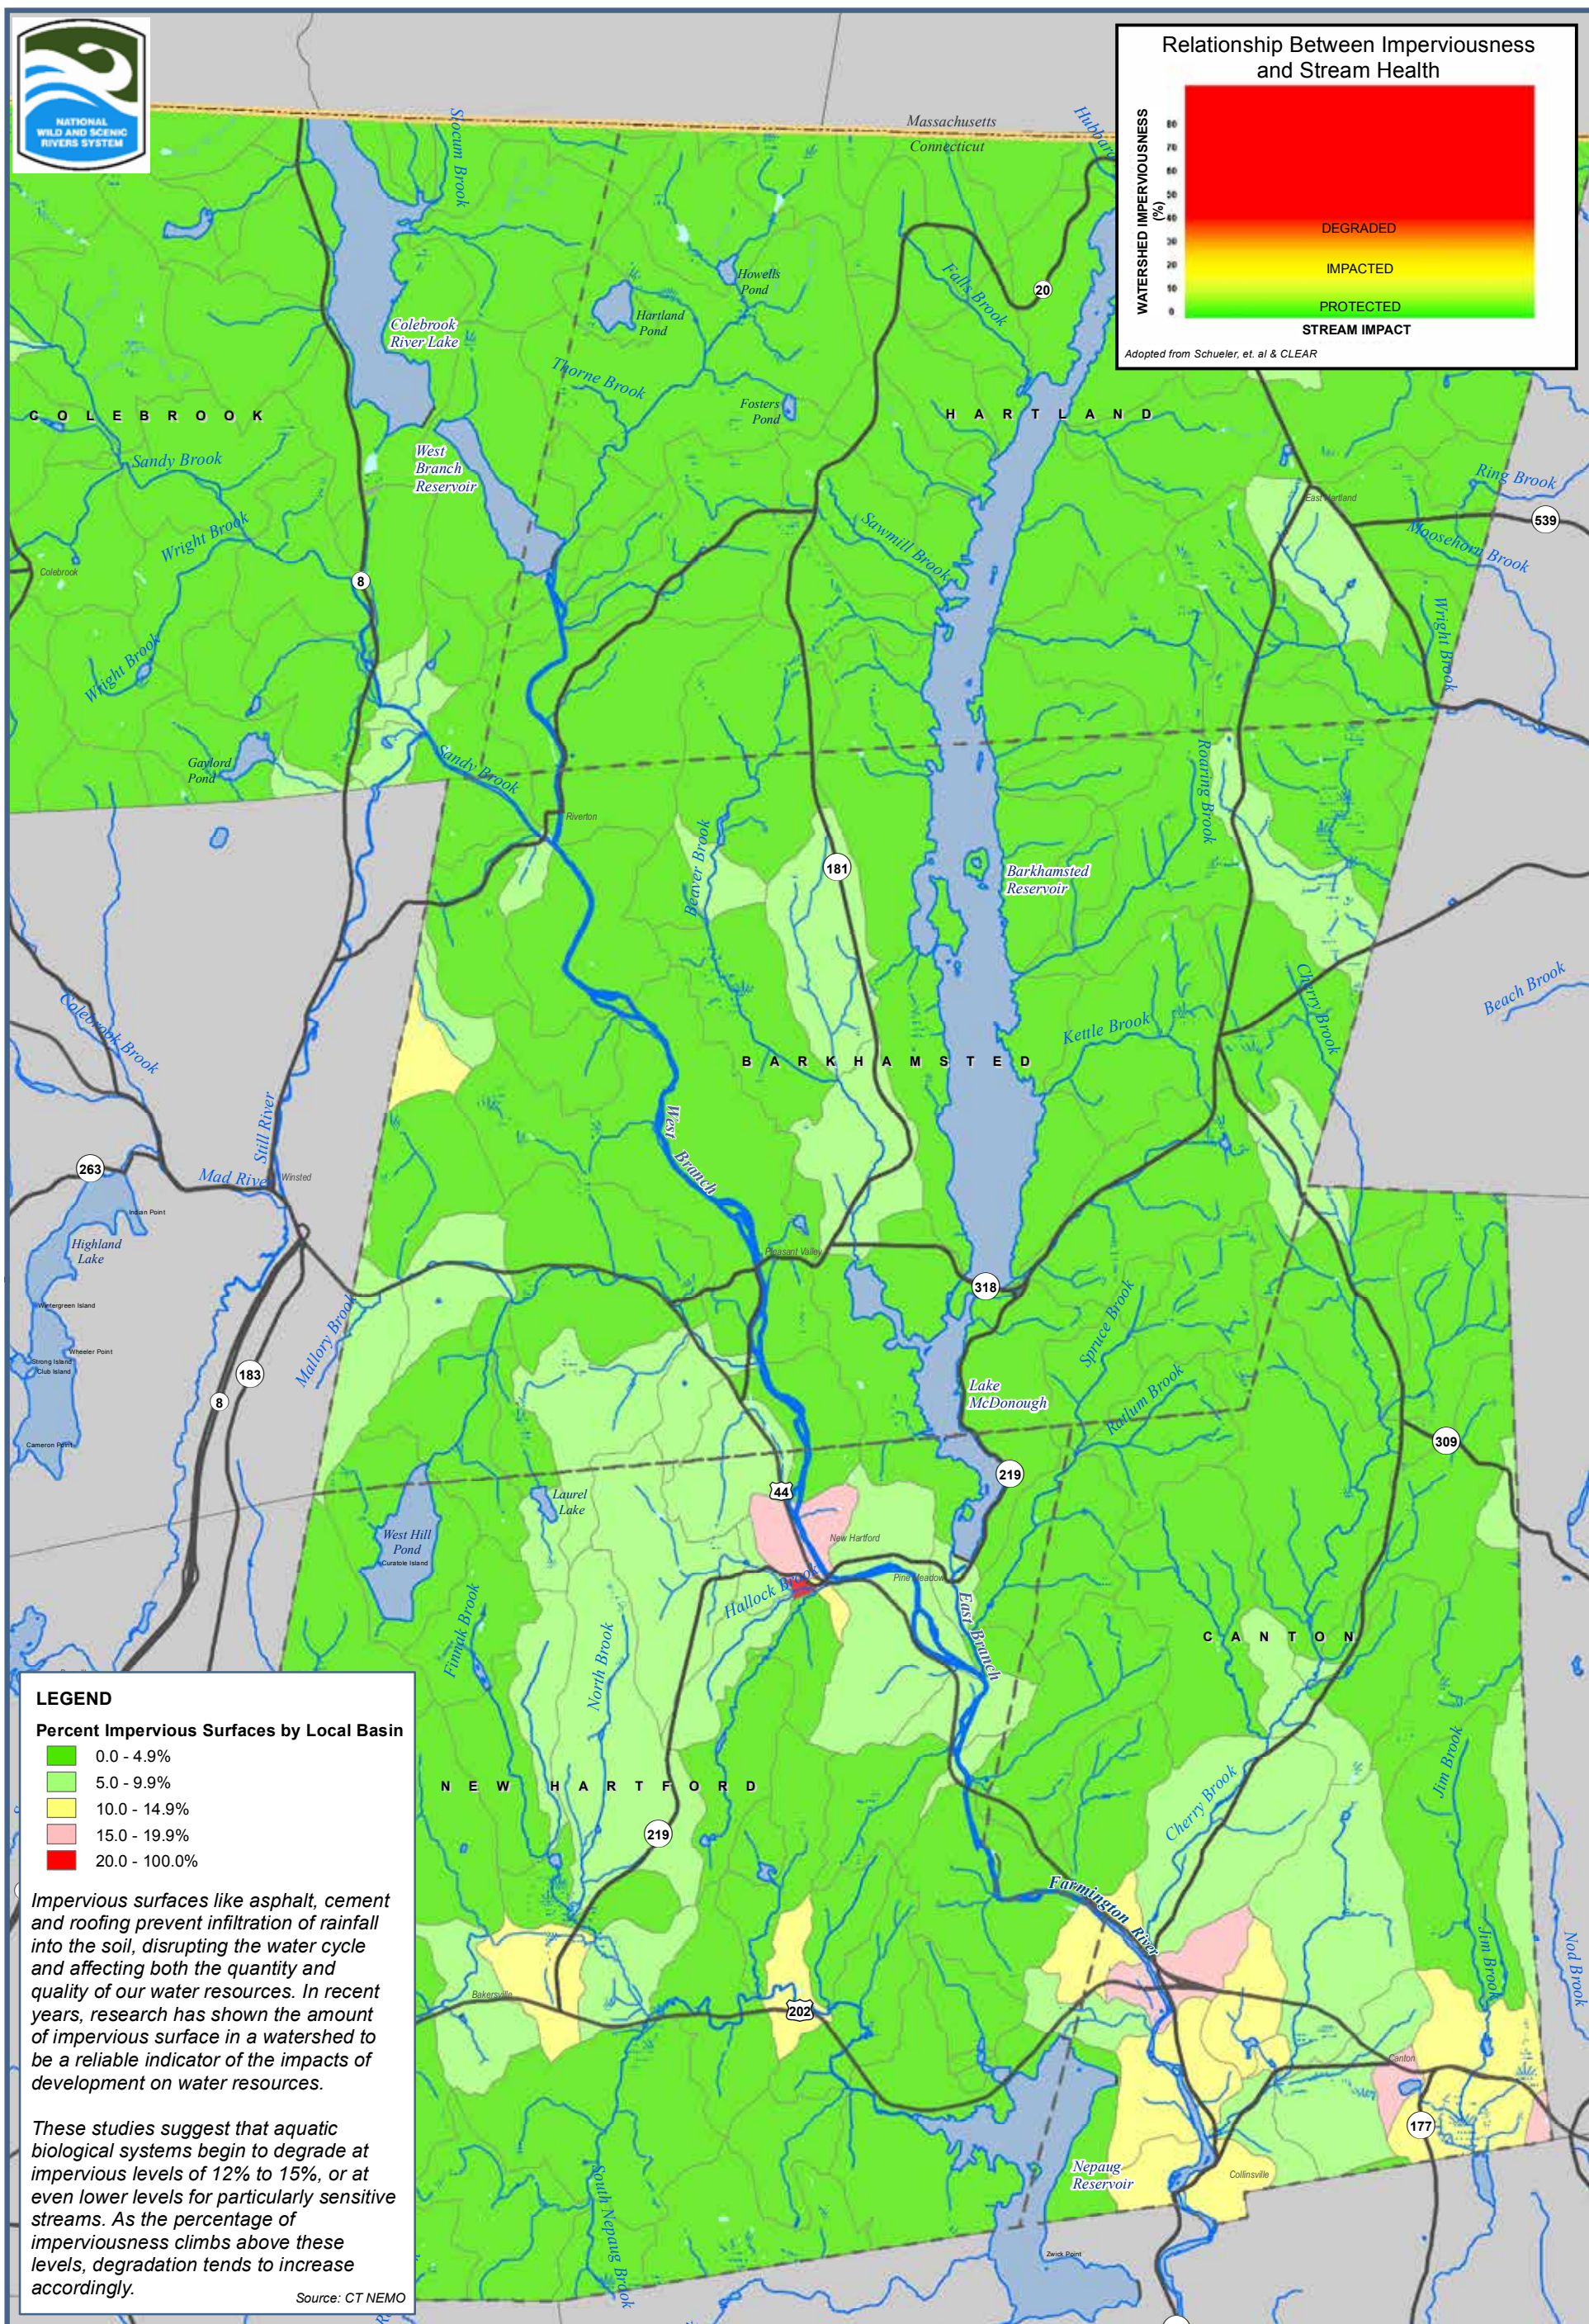
FIGURE 15

Percent Impervious Surfaces by Local Basin

Impervious surfaces like asphalt, cement and roofing prevent infiltration of rainfall into the soil, disrupting the water cycle and affecting both the quantity and quality of our water resources. In recent years, research has shown the amount of impervious surface in a watershed to be a reliable indicator of the impacts of development on water resources.

These studies suggest that aquatic biological systems begin to degrade at impervious levels of 12% to 15%, or at even lower levels for particularly sensitive streams. As the percentage of imperviousness climbs above these levels, degradation tends to increase accordingly.
